CFM56 TRF Eddy Current

2015 A4A NDT Forum Fort Lauderdale, FL

CFM SB's 72-0568 and 72-0579 provide the inspection details for the repetitive on-wing eddy current inspections. SB effectivity is dependent upon TRF part number. AD is applicable only to part numbers in SB 72-0579.

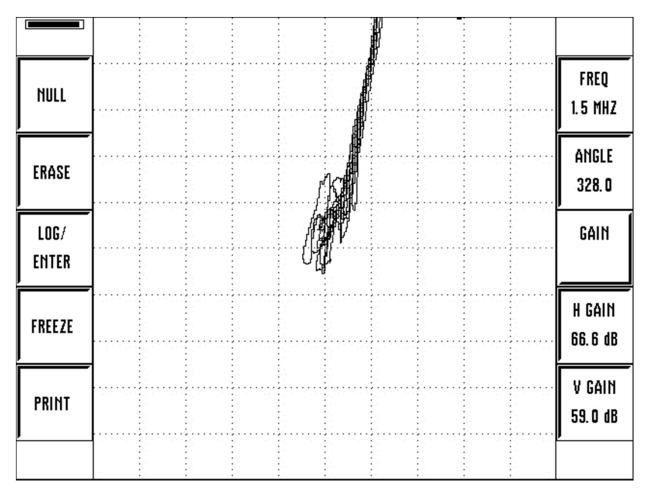
What does it look like when we scan across the weld?

Rejectable signal = 1.5 divisions. Houston, we have a problem!

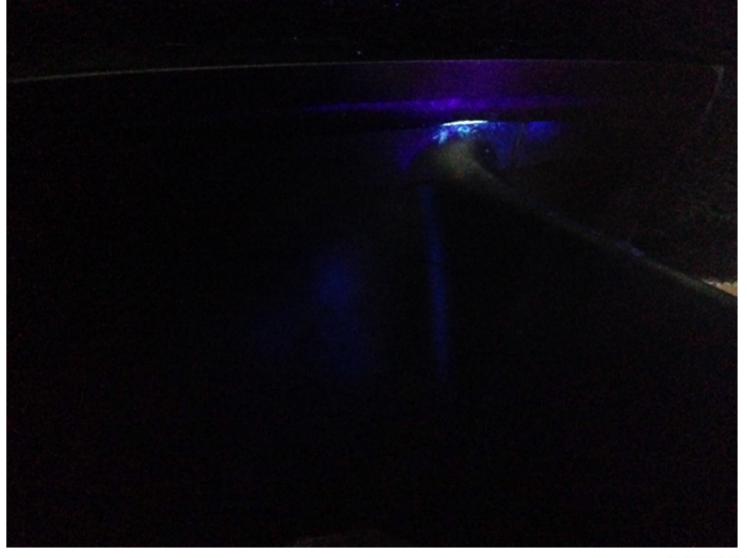
But what is this???

NULL	Crack Indication	FREQ 1. 0 MHZ
ERASE		ANGLE 89. 0
LOG/ Enter	Lift Off Indication	GAIN
FREEZE		H GAIN 47.0 db
PRINT		V GAIN 67.0 db
	1

The scrap frame section is cracked in area C1!
