Bulletin 2024.4 Additional Required Procedures for Water Barrier Filters December 12, 2024

3.19. Water Barrier Filter Element Supplemental Change Procedures

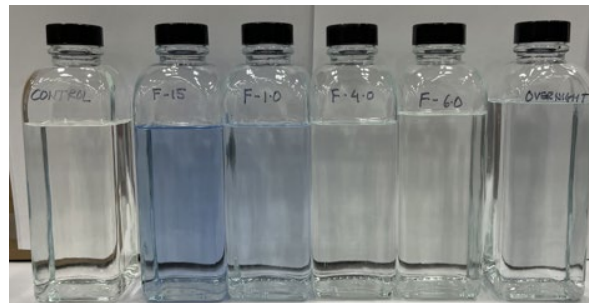
In a Product Safety Awareness Bulletin dated December 2024, Parker Velcon notified the aviation fuel industry that a manufacturing defect affecting a small number of CDFX water barrier elements has been detected. A defect in the black outer sleeve (outer screen) production allows blue dye to wash off the element upon initial fuel exposure, resulting in a bluish fuel discoloration. Jet fuel dyed blue is not acceptable for aviation use.

Parker Velcon has provided the following photo example of fuel discolored with blue dye:

Parker Velcon is recalling elements manufactured prior to December 31, 2023. Those water barrier filter elements shall not be installed after December 12, 2024. In addition, Parker Velcon is directing additional checks for water barrier elements manufactured from January – June 2024.

A4A is immediately modifying the ATA103 to require additional commissioning checks for all water barrier filters, regardless of brand or manufacturing date.
