Detecting Major Damage in Internal Composite Structural Components

**2016 Airlines for America Nondestructive Testing Forum
26-29 September 2016, San Diego CA**

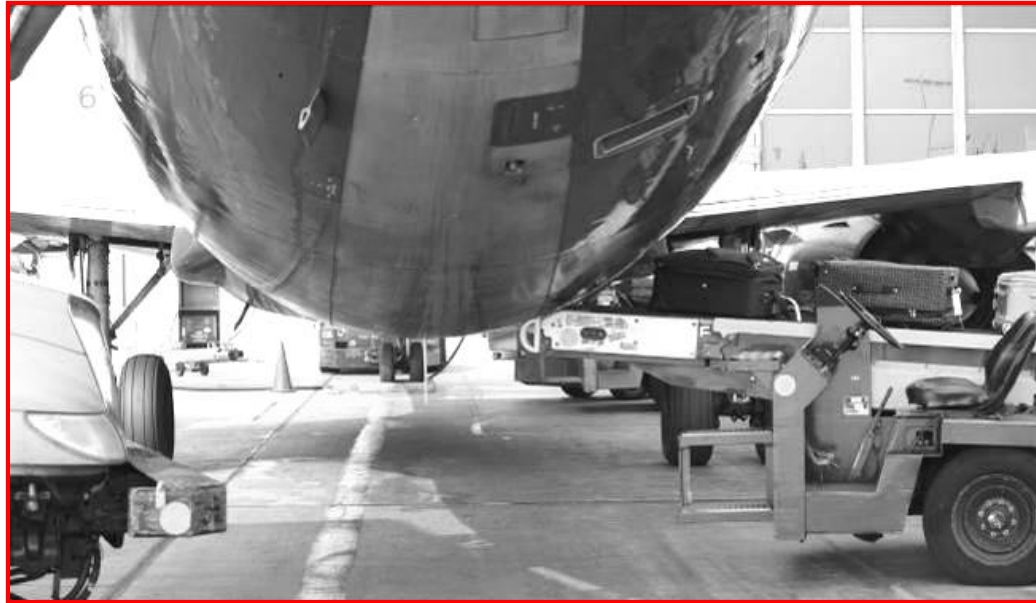
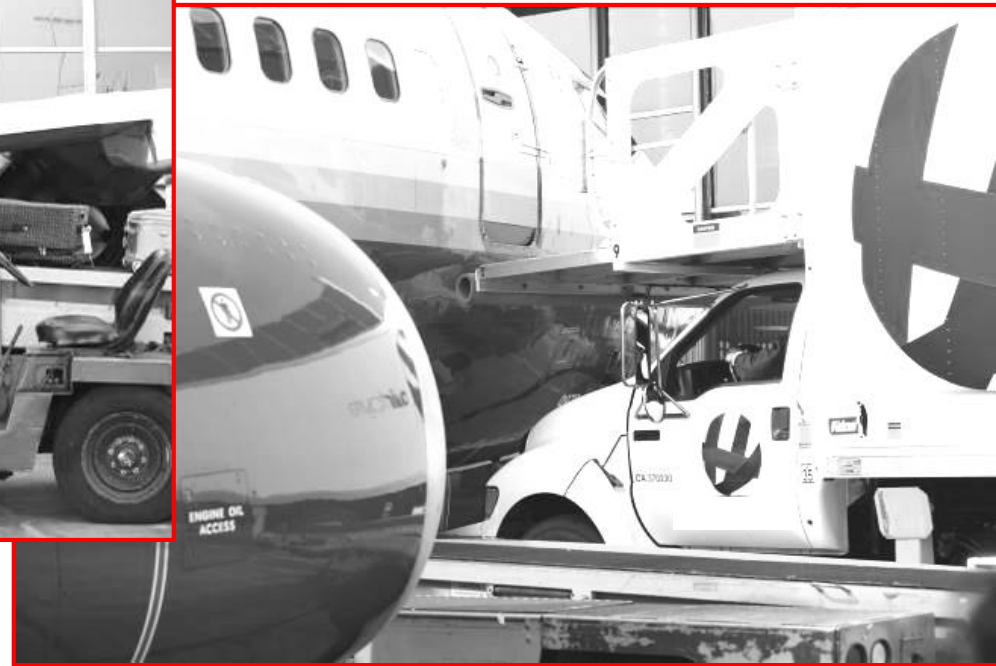
Motivation

- damage from ground service equipment (GSE) can be difficult to visually detect
 - blunt impact damage problem
- key interest: presence of **major damage to internal structure** (frame, shear tie, stringer)
 - cracks usually not detectable by typical one-sided NDE from external skin
- need quick NDE tool to decide if further inspection/action needed

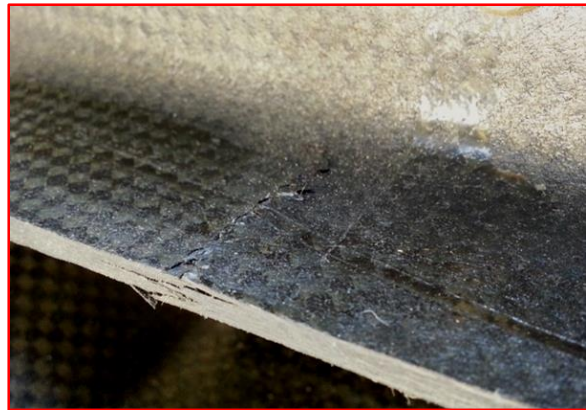
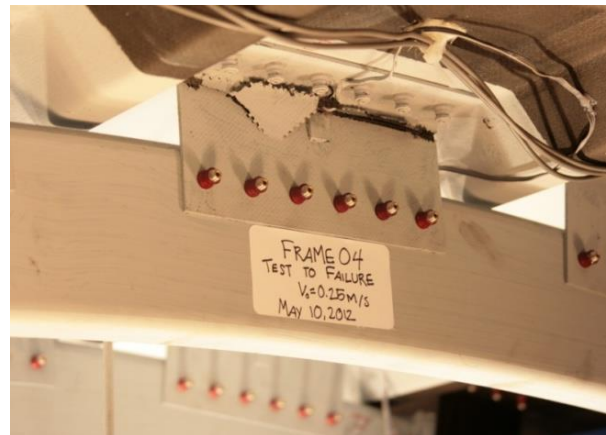
Approach

- pitch-catch guided wave approach
- structures of interest form waveguide paths
- C-frame is like 1D waveguide – wave transmission along length affected by damage
 - excitation → through skin → in through shear tie → travel along frame → out through various shear ties → through skin → sensor
 - broken shear tie and frame will attenuate/modify signal
- key issues:
 - dominant frequencies associated with waves/modes sensitive to damage
 - complex geometry, many interfaces
- stringer heel crack – wave propagation through skin and stringer paths

- Acoustic Excitation Through Shear Tie Station 6
- Sensor Readings at Stations 7 & 8 Normal w.r.t. Baseline
- Sensor Reading at Station 5 Shows Low/No Signal Due to Fully Crushed Shear Tie
- Sensor Reading at Station 4 Attenuated Due to Frame Crack (Low/Lost if Through-Width Crack)

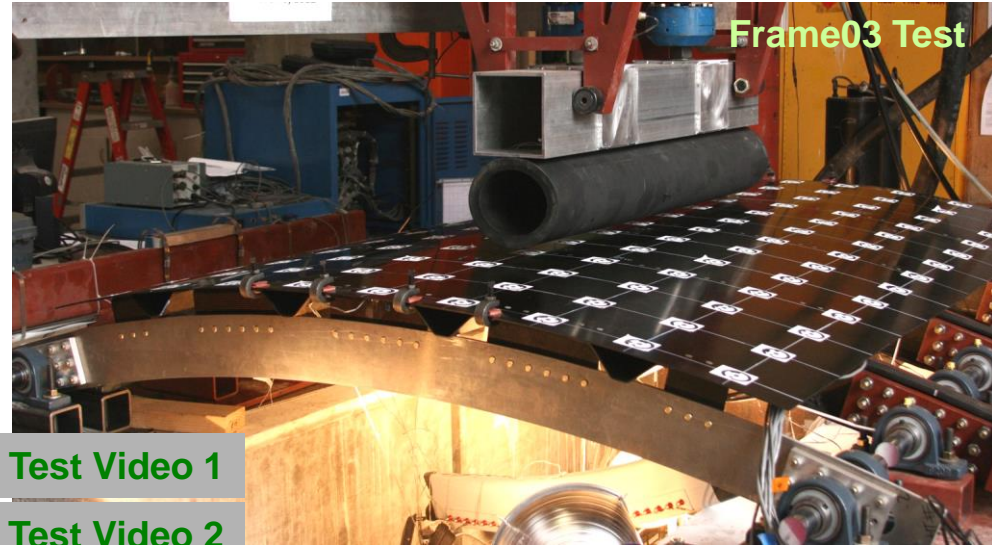
Test Specimens

- previously-tested specimens from FAA project “Impact Damage Formation on Composite Aircraft Structures”
- FrameXX panel series
 - C-frame crack
 - shear ties crushed
- StringerXX panel series (stringer-only panels)
 - stringer-skin disbonding
 - stringer heel crack
 - shear ties crushed

- C-frames – pristine stand-alone frames
 - 3 new frames fabricated
 - 1 previously-fabricated “spare”
- shear ties – qty ~16 available “new” untested

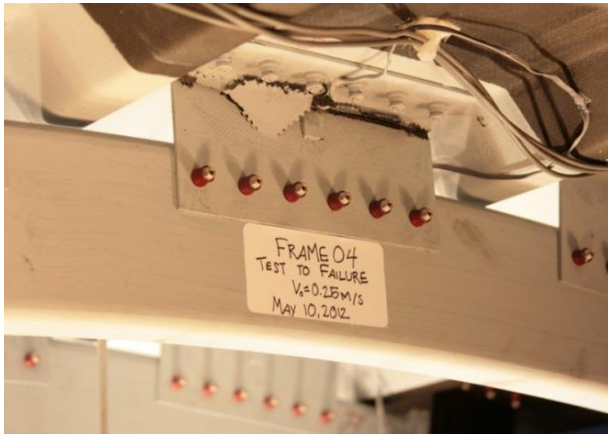
Prior Specimens – Damage Survey

- **partially-cracked frame** available in panel Frame02
- **cracked/crushed shear ties** in all specimens (Frame01 to Frame04)
- **stringer disbonds** in panel Stringer02
- **stringer heel crack** in panel Stringer05

Partially-cracked frames – from specimen Frame02

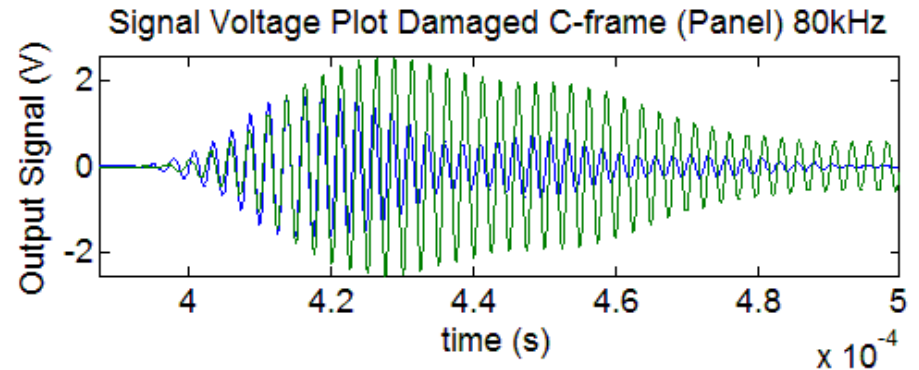
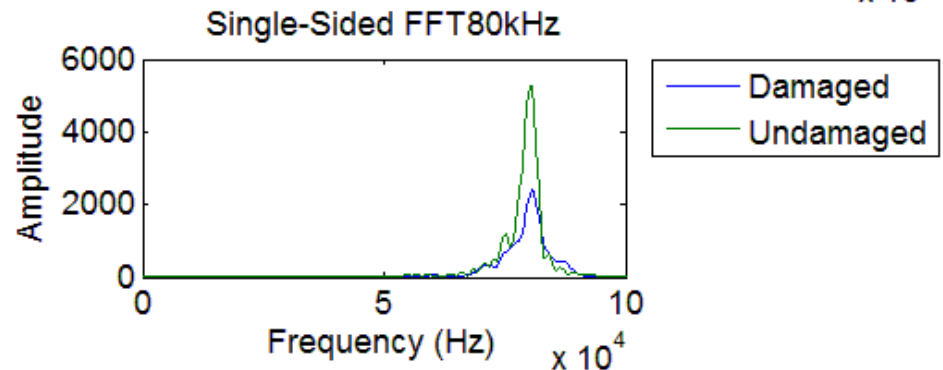
Partial Crack

Sensors located 305 mm (12 in.) from Excitation.

Excitation: 5-cycle sinusoidal burst sent at various frequencies.

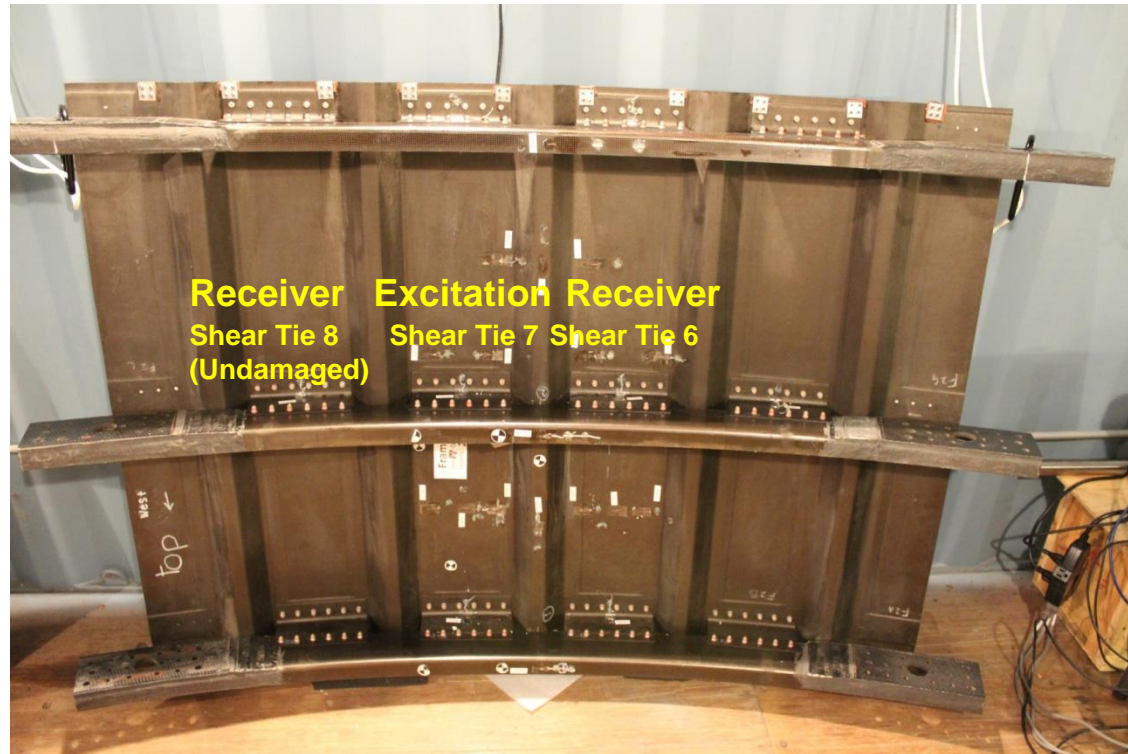
Skin-Side View

- **GUV Test on C-frame02 Section:**
 - **Skin to Skin (Damaged Path through ST06 vs. Undamaged Path through ST08)**

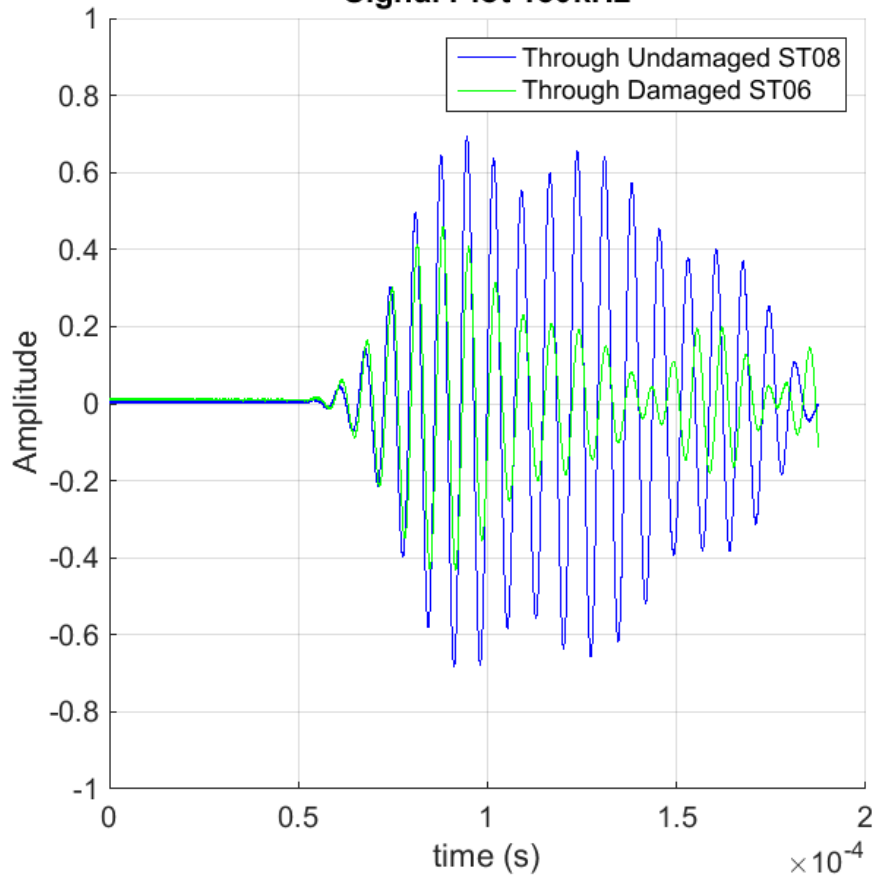
Signal Plot 150kHz

- **GUV test result: 150kHz Excitation**
 - **Excited from ST07 Skin to ST08 Skin and ST06 Skin**

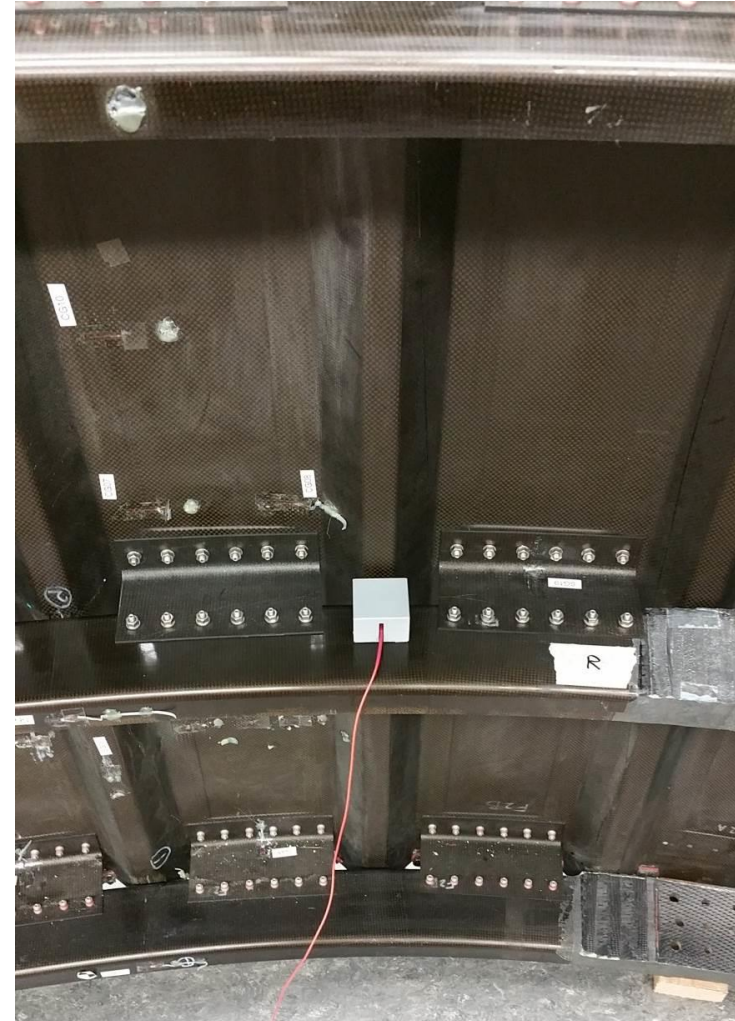
Path: Through Skin vs. Into C-Frame

- **Frame02 Panel: Skin vs C-frame**

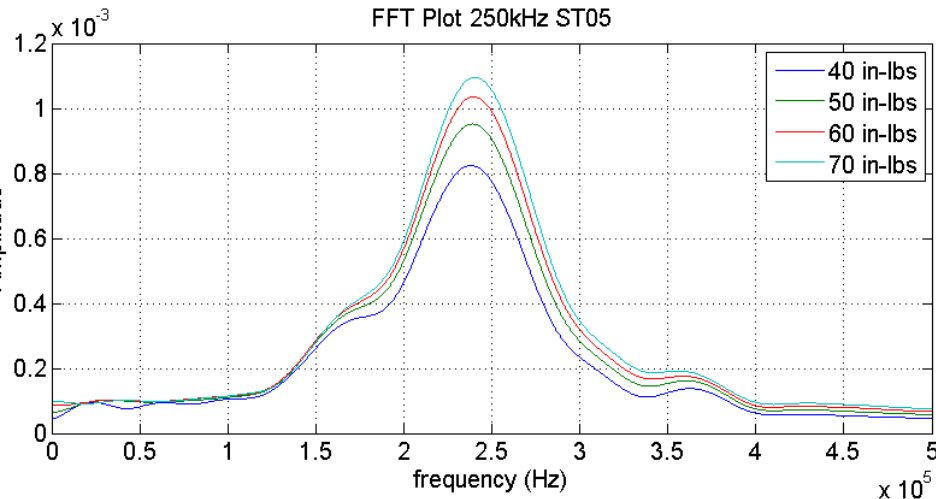
Bolt Torque Differences

Continually increasing with higher torque (up to 70 in-lbs)

- At 50 kHz, non-monotonic behavior, with peak transmission at 20 in-lbs
- At 150 kHz, no strong dependency on bolt torque above 20 in-lbs
 - assumed to be from sensor's in-plane dominant sensitivity at 150 kHz
- At 250 kHz, increasing bolt torque from 20 to 70 in-lbs shows almost linearly-increasing wave energy transmission
- Transmission sensitive to torque, frequency and sensor**
