Evaluation of Barkhausen Noise During Overhaul

DELTA TechOps

Delta TechOps | September 24, 2015 |

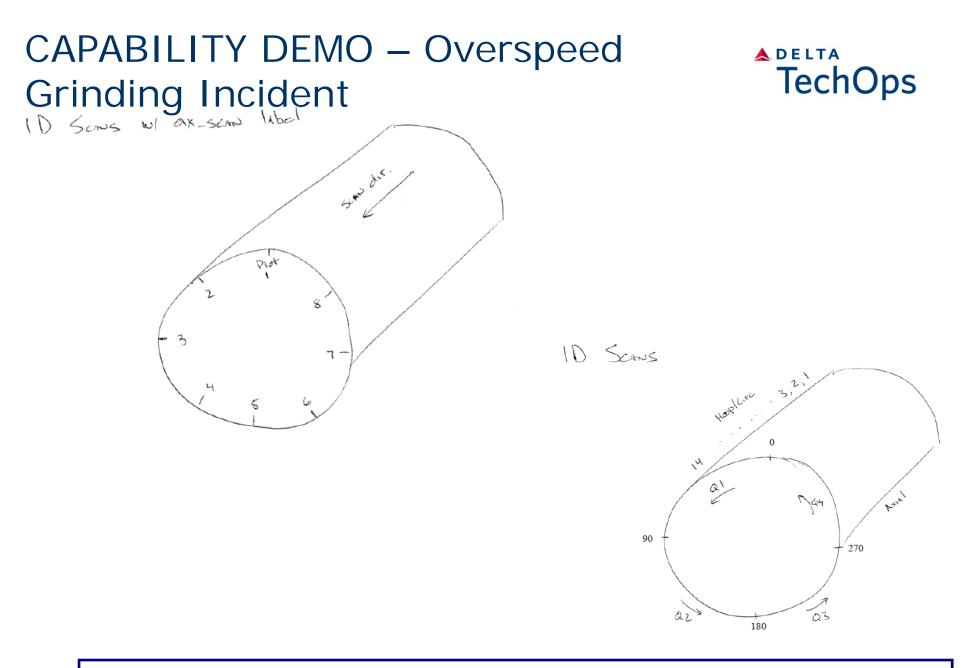
Axial and Circumferential 'segment' scans were acquired

- •AST visit to demo and conduct study
- Two 'suspect' gear cylinders, 1 completed 'overhauled' gear, and Engineering specimens used
- •BN inspection indications (through 0.008" thick chrome)
- •Later, cylinder found 'overtemp' by Nital Etch, <u>and</u> cracking discovered with MPI in areas that BN inspection had identified as 'suspect'.
- Proves the 'capability' of Barkhausen Noise inspection to detect grinding burns through chrome(0.008").

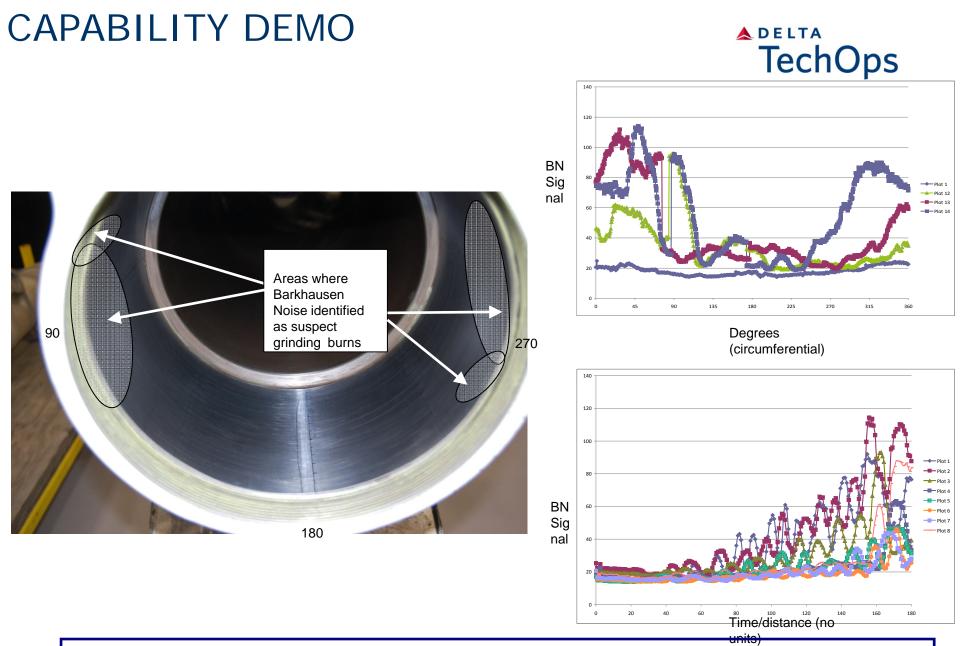
BNI indications in both axial and circumferential scans

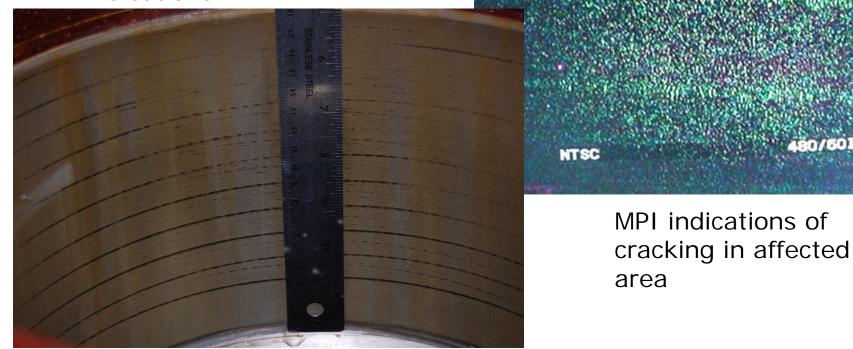
Nital etch indications match BN indications

Nital Etch and MPI confirmed the BNI indications as grinding damage

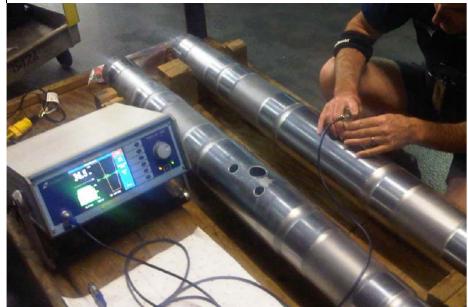
- A. Rollscan 300 CPU
- B. High Output Axial OD Sensor, See figure 2.
- C. High Output Circumferential OD Sensors. See figure 2.
- D. Reference Pin 161N4001-2 BNR
- E. Tape, PTFE, Teflon, or other high wear resistance tape with a thickness of 0.003 ± 0.001

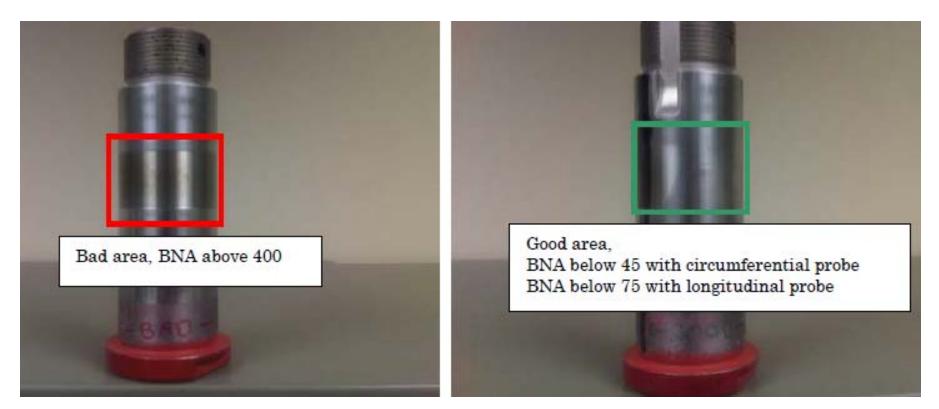
Reference standard made from scrapped pin

- 1. Ref Std made for 4340M using scrapped pin
- 2. Internal Delta Technique Sheet made.

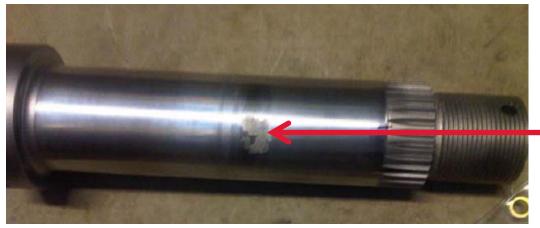
Chrome wear provides visual & BNI indication

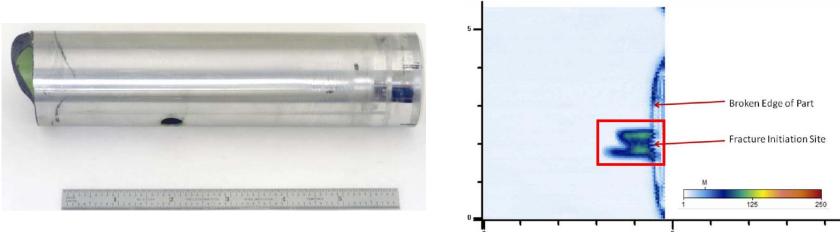
History of issues, which could be solved with BN

- 1. Broken half inspected by DL strong BN indication
- 2. Boeing confirmed BN indication
- 3. "...showed evidence of base metal grinding burns under the Chrome plate at the site of fracture origin."
- Other Boeing examples of heat damage
 - Grinding during overhaul and
 - In-service damage (poor lubrication)
- Delta has had 4 broken axles due to heat damage

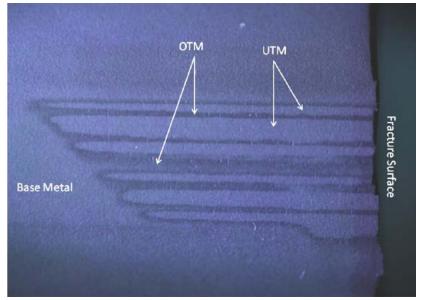
Nital etch

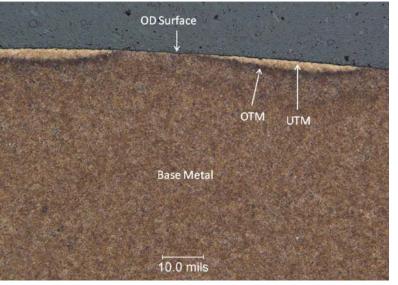
MPI

Depth of 4 mils
